Technical Preservation Services
Preservation Assistance Division
National Park Service
U.S. Department of the Interior
Washington, D.C.

Interpreting the Secretary of the Interior's Standards for Rehabilitation

Volume III

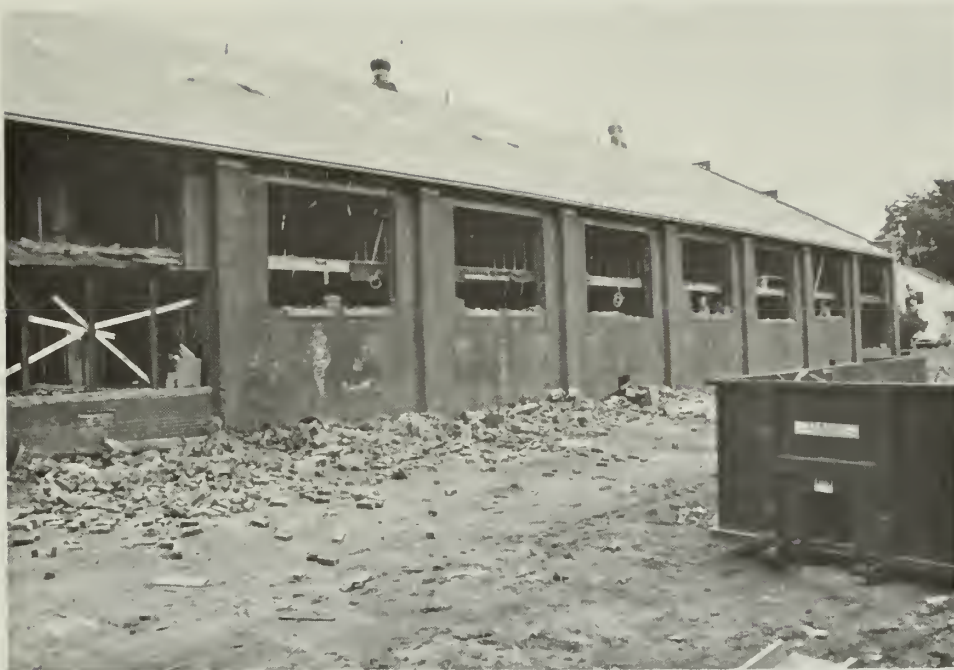
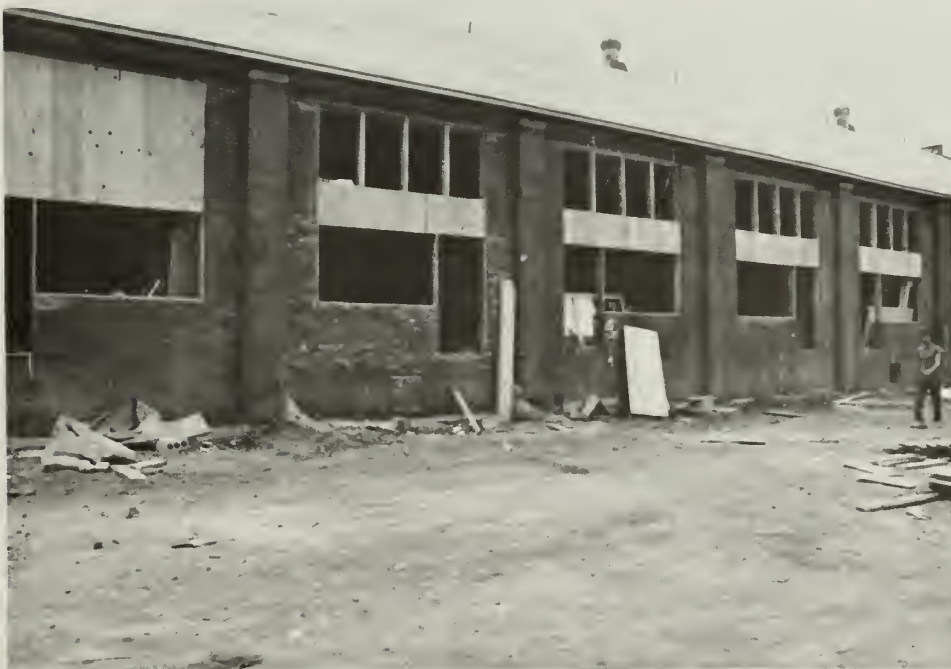
5-6. The rear elevation of the drill shed during rehabilitation. Note the extensive loss of brick, and how the character has changed with the removal of the multi-paned wood sash and the creation of large openings.

The drastic changes to the fenestration of the rear elevation were cited as cause for denial. The existing historic window openings could have been altered in a manner that would have provided light and access to the rear apartments while still leaving enough brick to maintain the character of the rear wall. Instead, as the project was carried out, the wholesale removal of the sash and most of the brick between the piers added up to a significant loss of historic fabric. However, it is the change in character of the rear elevation that is most damaging. Installation of the prefabricated panels resulted in unacceptable changes in: color and texture (brick red to stark white, smooth panels); materials (brick and wooden window sash to prefabricated panels and aluminum windows); composition (distinctly vertical to distinctly horizontal); and design (industrial to residential). Addition of the wooden decks further obscured what remained of the brick, and emphasized the incongruous domestic appearance of the rear elevation. Furthermore, the elevation now is highly visible to those entering the apartments from the parking lot, and to neighboring houses.

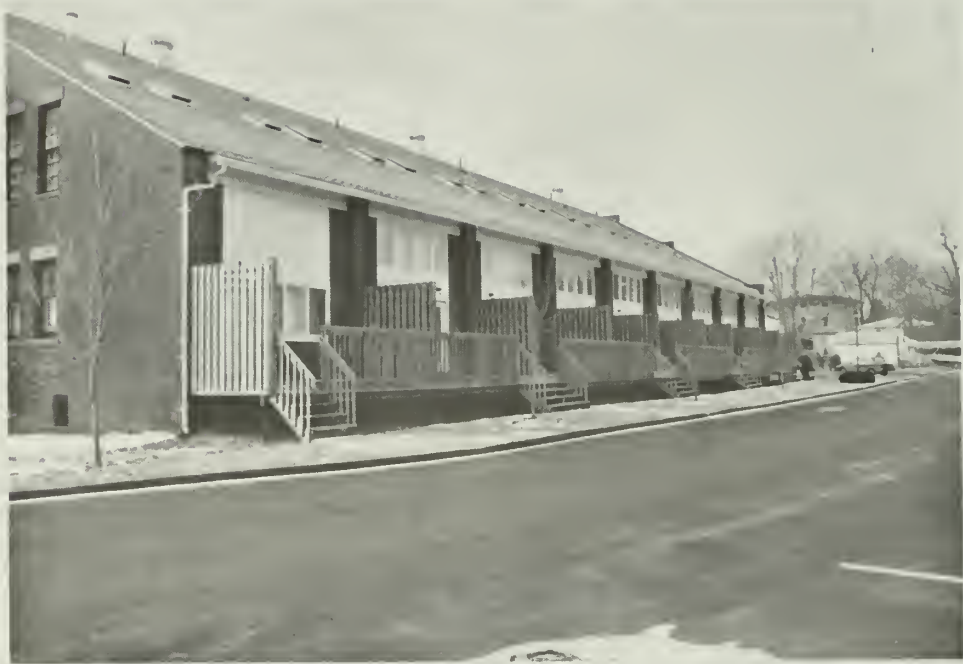
7. The rear of the drill shed showing the completed rehabilitation with the new skylights in the roof, the prefabricated panels filling the former bricked areas, and the new wood decks and privacy fences facing onto a parking lot at the rear of the property.

Despite several alterations made in the 1950s and some deterioration and vandalism which occurred during the nearly 15 years the buildings had been vacant, the armory had survived in a remarkably intact state prior to rehabilitation. The interior of the head house, including a large entrance hall, company parlor, and numerous small rooms on both floors, easily accommodated the apartment conversion which was accomplished with a minimal loss of historic fabric and character. The interior of the 75 x 300 feet drill shed was a completely open space with exposed steel trusses and a suspended gallery at one end (see illus. 4). During the rehabilitation this large open space was converted into twenty apartments by creating two floor levels. To provide light into these apartments, skylights were added to the rear of the roof of the drill shed, and the rear wall was reconfigured by removing the original paired nine-over-nine wood sash windows along with a substantial amount of brick between the piers (see illus. 5-6). Nine prefabricated, panelled units which incorporated walls, windows and doors were inserted in these newly made openings along the entire length of the rear elevation. Wooden decks with privacy screens and steps to the parking lot were added for the first floor apartments (see illus. 7).

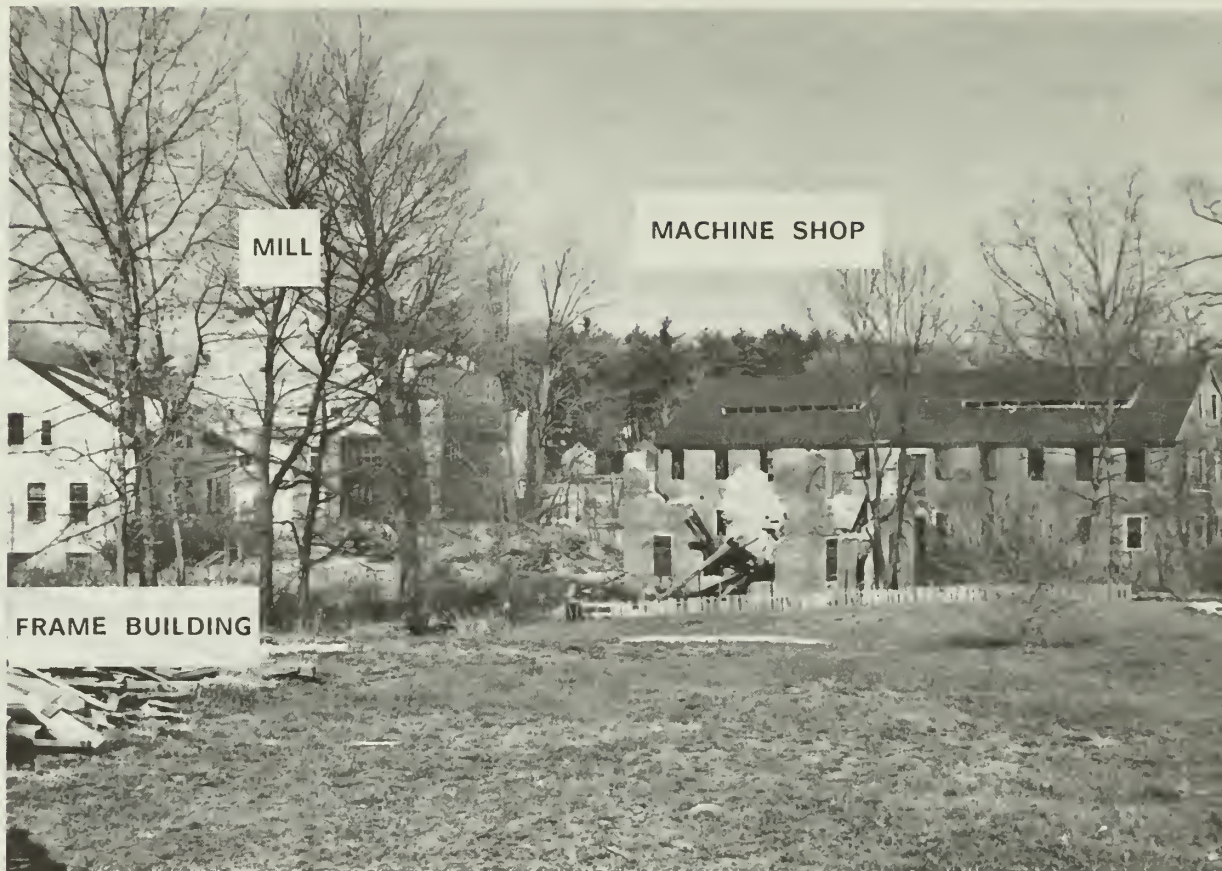
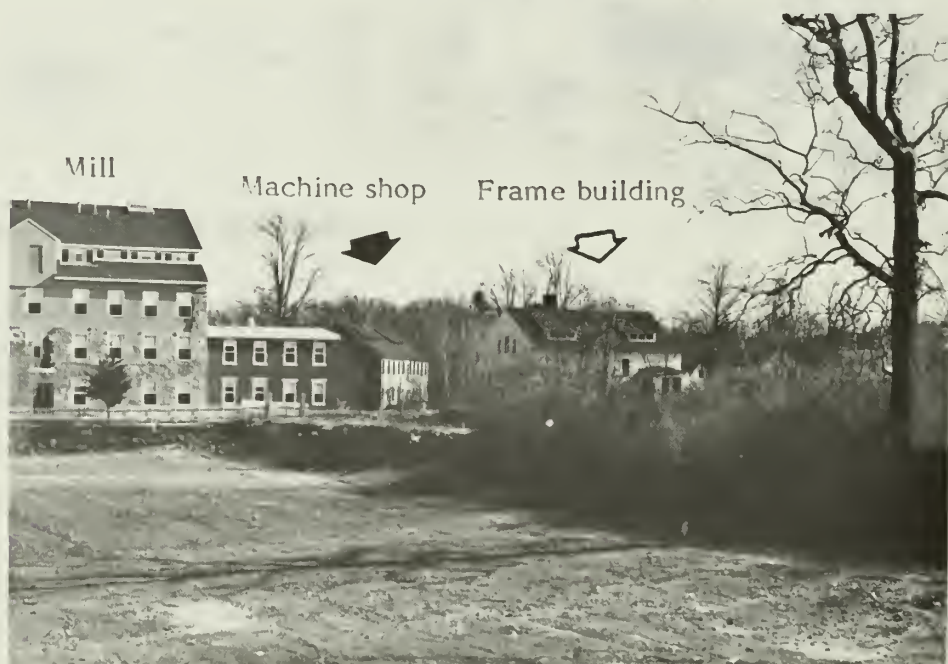
2-3. Pre-rehabilitation views of the machine shop, frame building, and the mill. The National Register record states "the mills are set across a wide meadow at the end of a formal system of waterways; their isolation points to the mills as a distinct unit." Note the unadorned, simple quality of these industrial buildings.

Application: A historic district significant as an early-nineteenth century textile manufacturing center was rehabilitated as a rental housing community. The district was significant in part for its founder's early attempt to group buildings by their functions (such as housing and milling) to take advantage of the natural terrain. Historically, milling functions were placed adjacent to the river where a waterway system was constructed. Buildings for housing and community activities were grouped separately across fields (see illus. 1). Although industrial functions had ceased years before, and the buildings were deteriorated at the time rehabilitation began, the historic setting of the district, in particular the portion of the district where milling functions occurred, remained intact. The industrial portion of the district included a large mill spanning the river, a machine shop, ruins of another associated mill building, an early twentieth century frame structure used as an office, and waterway system linking the buildings to the pond and river. These buildings and structures were situated across a field and visible from the main street running through the district (see illus. 2-3).

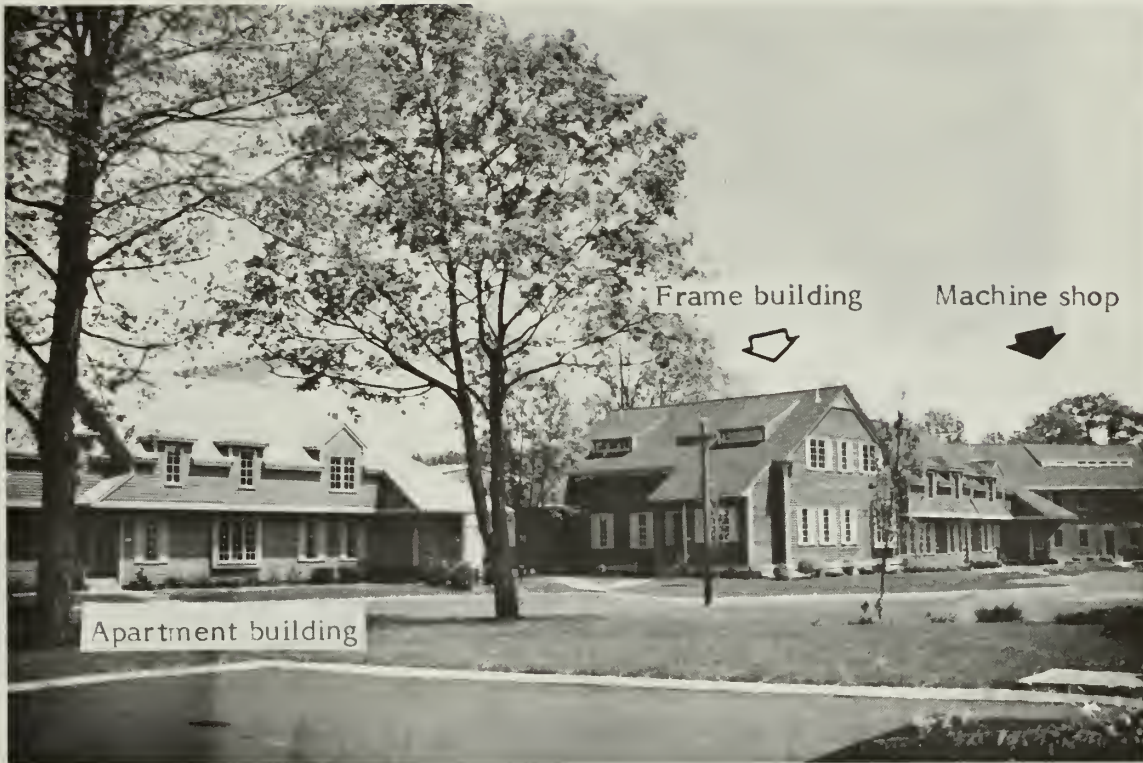
4. Post-rehabilitation view of machine shop and frame building. Note alterations to the frame building and new construction in the previous open space. The new construction introduces a variety of architectural forms and features not found on the historic buildings in the district.

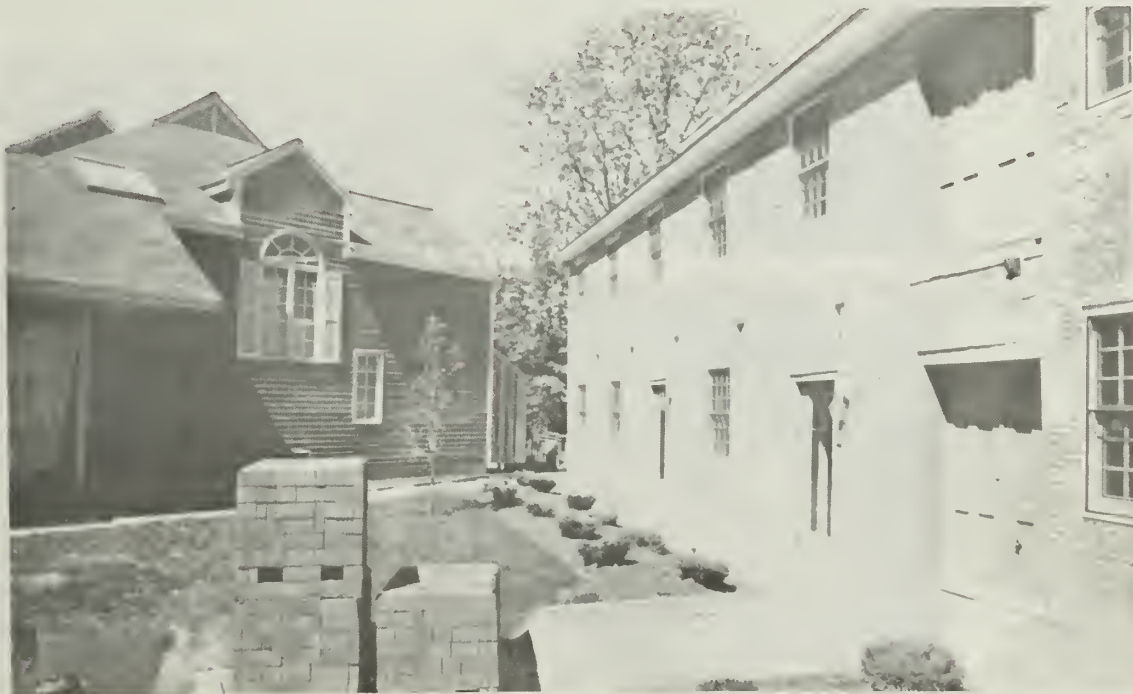
5. Note how close the frame building's new addition is located to the machine shop. A wood deck links the two structures. The new addition has created a more densely developed environment than existed prior to rehabilitation, obstructs the visibility of the machine shop, and has introduced architectural forms and features not found on historic buildings in the district. The new construction, therefore, has changed the visual qualities characteristic of the setting of this district.

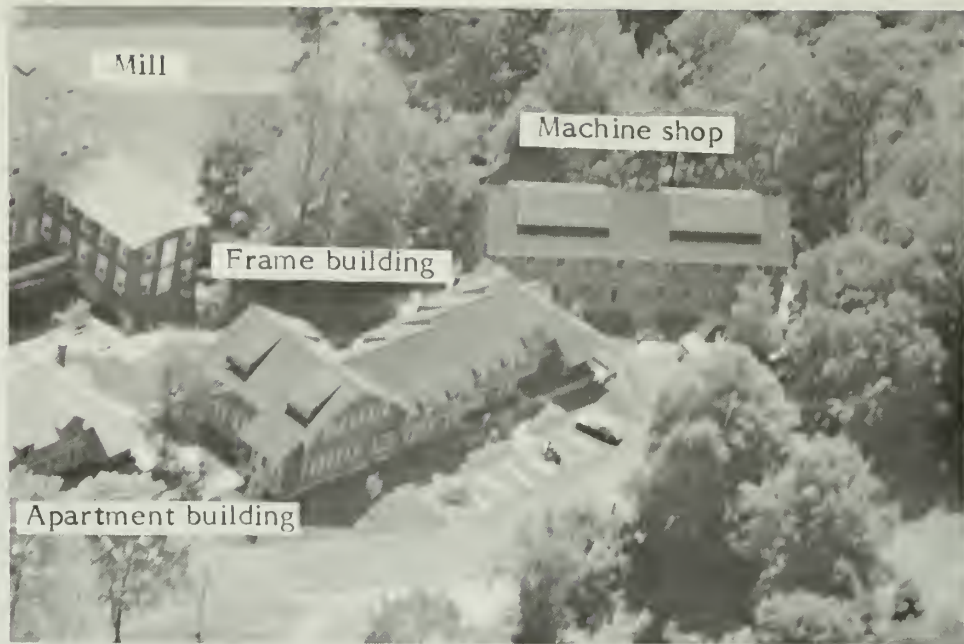
6. Aerial view of this portion of the district showing the alterations to the frame building, and a portion of the free-standing new construction on the left. The machine shop is in the center right of the picture, and the mill is located in the upper left corner. Note the more densely developed environment immediately in front of the machine shop.

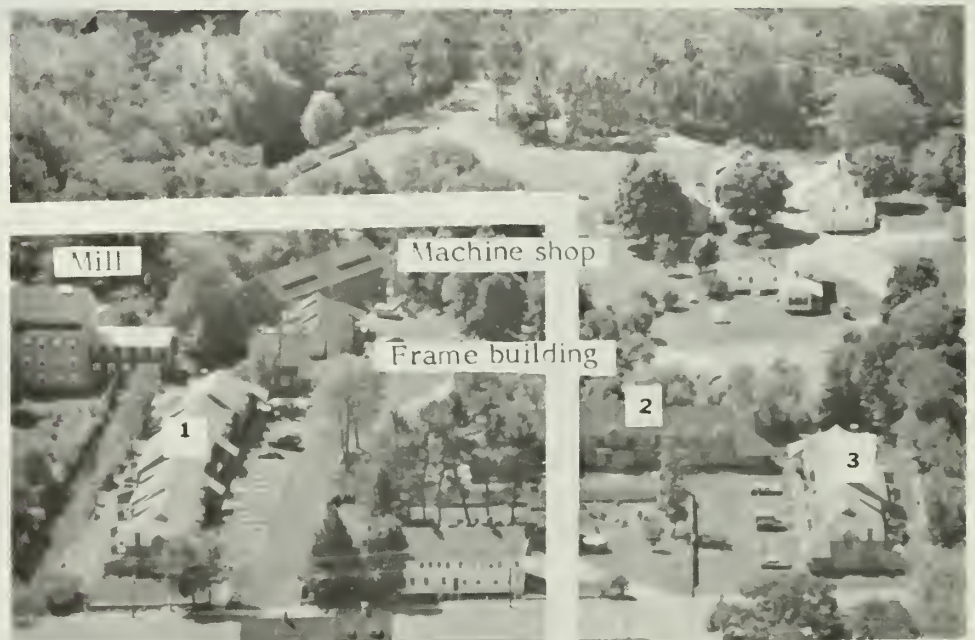
7. Aerial view showing blocks of new construction identified as 1, 2, and 3. White line is the approximate boundary of this part of the district.

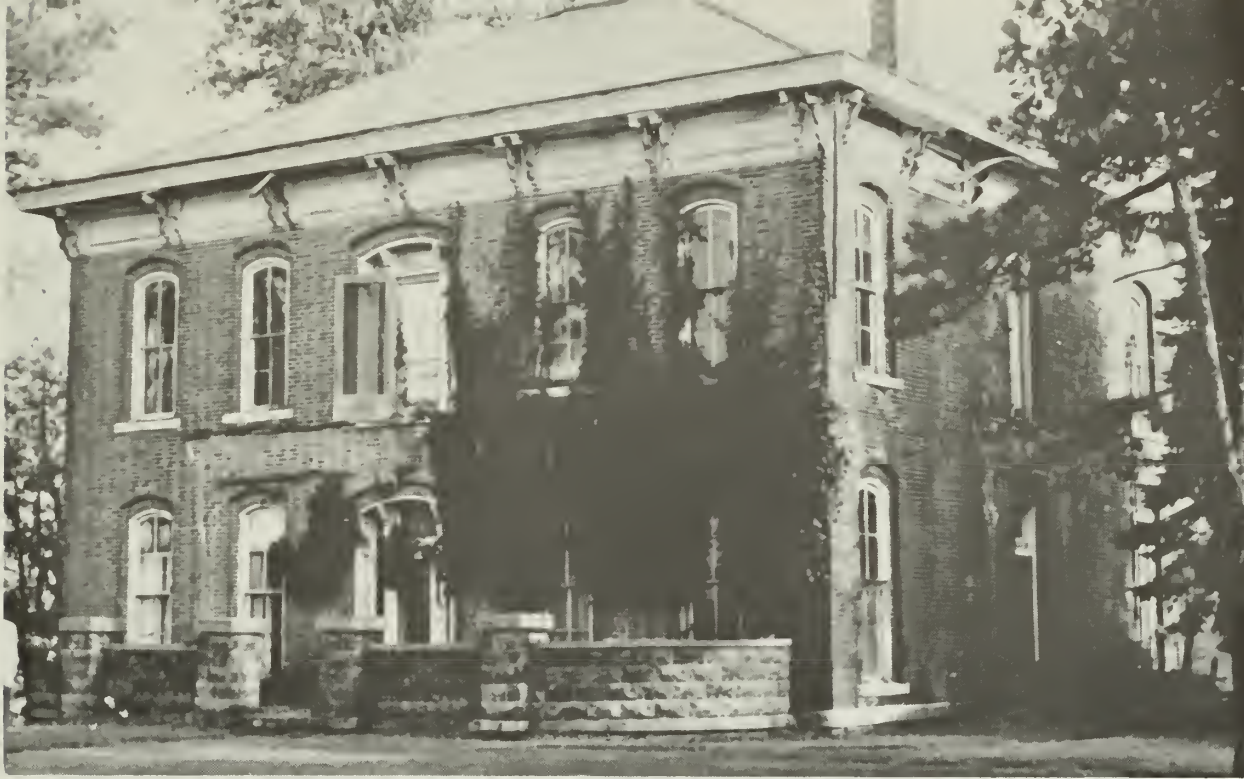
1. The house as it appeared when acquired by the current owner. Note the "ghost" outline of a porch on the front, the second floor exterior doors, and the elliptical cast stone terrace.

fact that exterior doors remained on the second story that had apparently opened out onto porch roofs) provided clues to the fact that porches had ever existed. Although the original porches were gone, a later, elliptical terrace surrounded by a low, rusticated cast-stone wall, probably constructed around the turn of the century, existed on the primary facade of the house at the start of the rehabilitation.

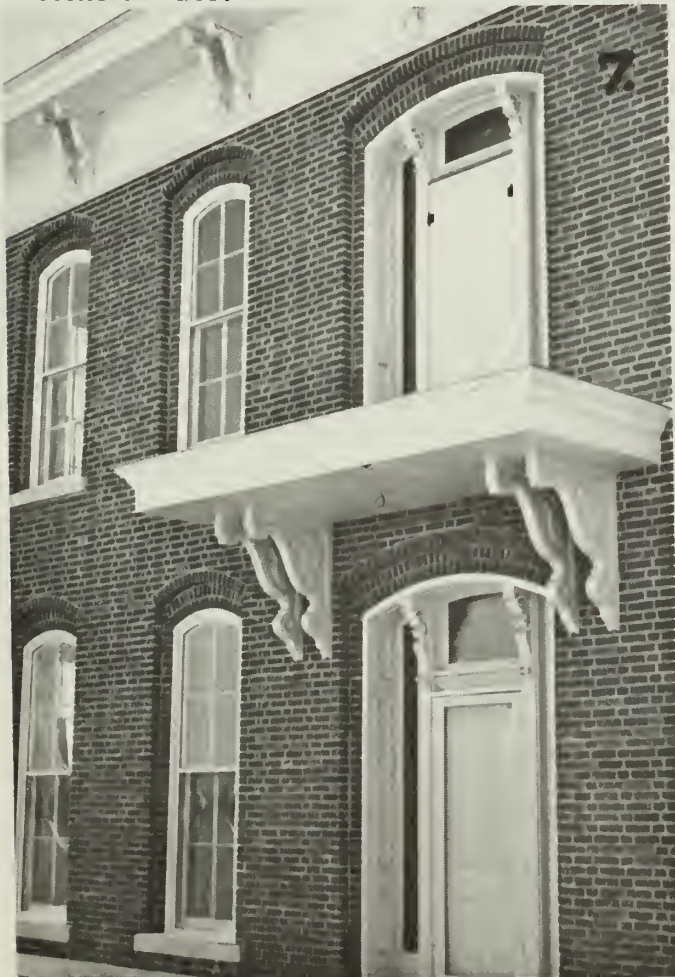
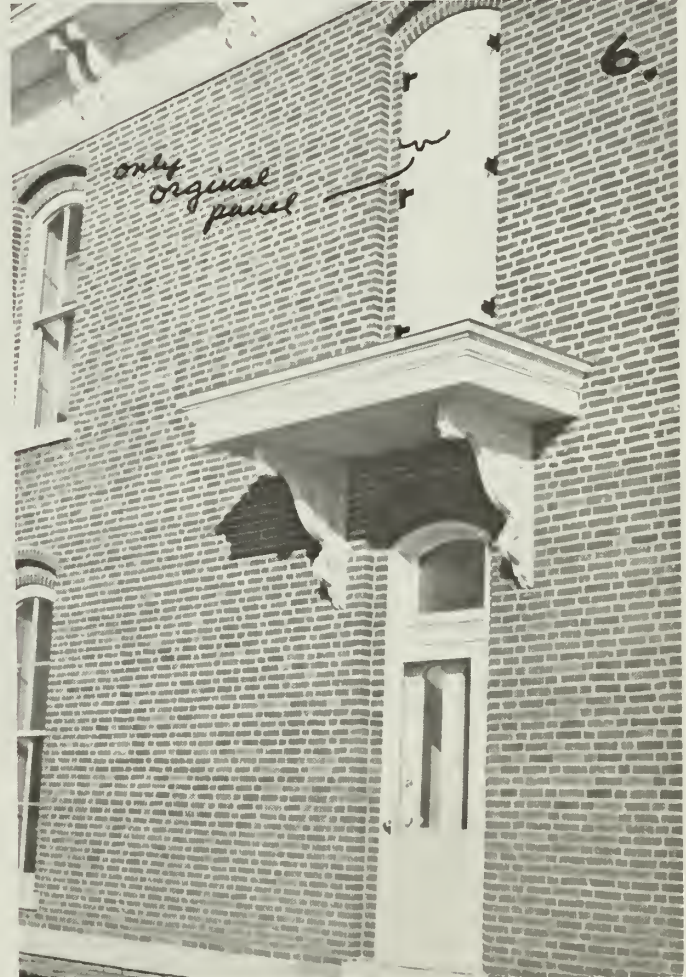
2-3. The reconstructed front porch (left) and the side porch (right). Their designs were based on bracket fragments found on the property combined with area residents' descriptions of the porches as they remembered them, but did not match the "ghost" outlines that had existed on the brick prior to cleaning.

As part of the rehabilitation, the owner removed this elliptical terrace and wall from the front of the house and decided to "reconstruct" the original porches. Instead of using the very distinct "ghost" outlines (which had been removed by the owner during cleaning of the exterior brick), the owner used pieces of wood brackets found on the property as models to construct new porches. These bracket fragments, the owner speculated, came from the "original" porches that had been described by area residents as preceding those porches which had left their physical profile on the brick (see illus. 2-3).

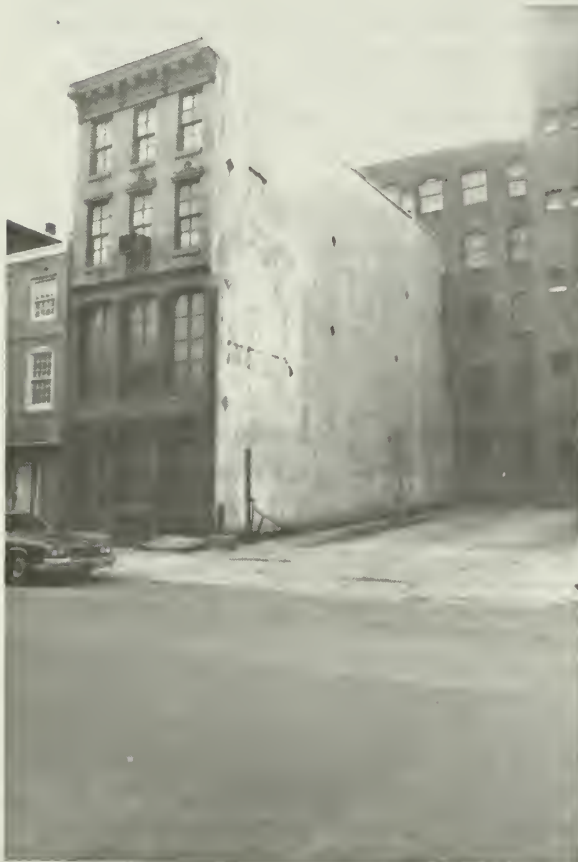
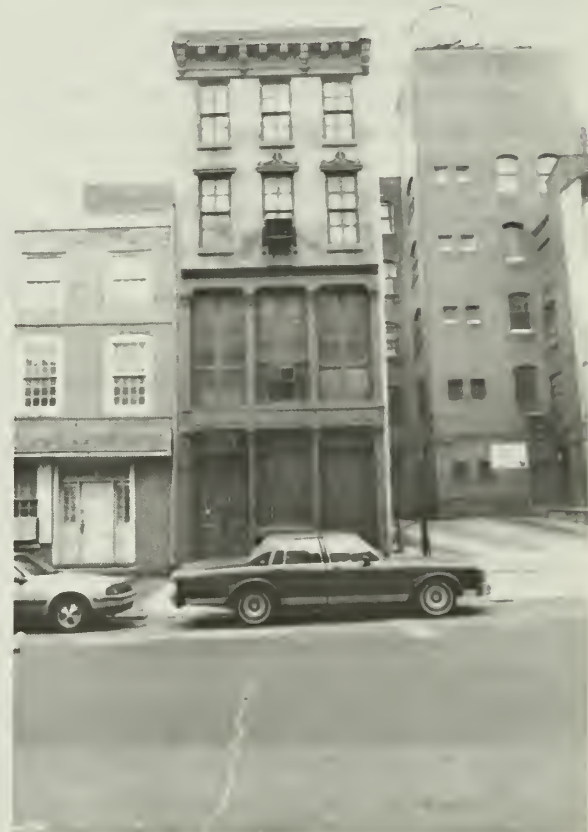
1 and 2. Four-story commercial structure before rehabilitation. Vacant lot and buildings at the right and to the rear were also part of the overall project.

Application: A four-story, three-bay brick structure built about 1869 and located in a historic district noted for its brick warehouse and commercial structures was rehabilitated for use as residential apartments. The rehabilitation of this structure was undertaken as part of a larger project involving three other buildings (see illus. 1 and 2).

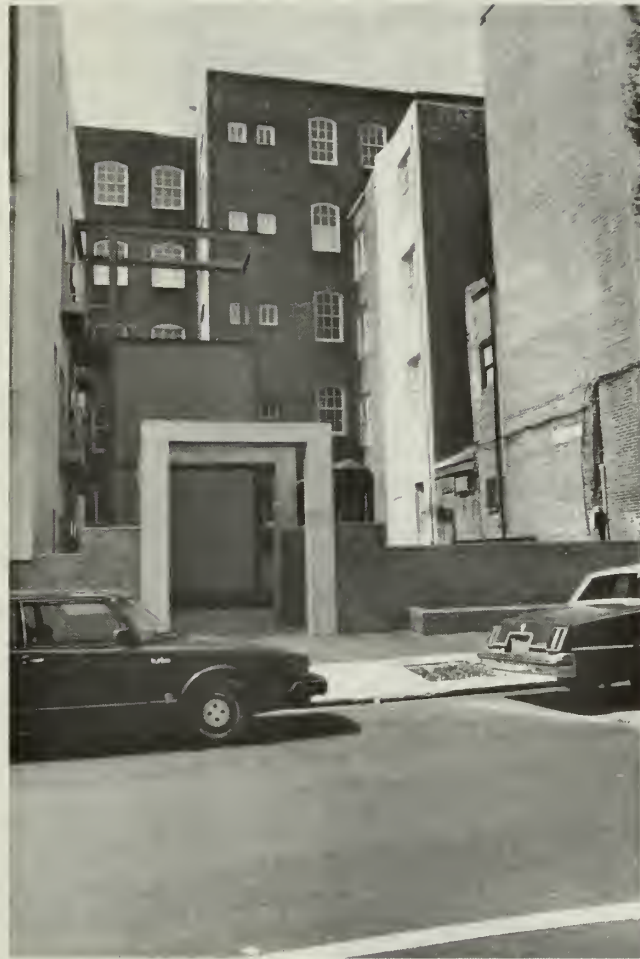
3. Entrance pavilion, front wall and stairtower are prominent new site features.

In addition, the prominence of the new work serves to diminish the prominence of the principal historic structure to which it is attached. The effect is that the historic building seems an appendage to the new entrance pavilion and stairtower rather than the reverse (see illus. 7). As a result, the project fails to meet the Secretary of the Interior's Standards for Rehabilitation.

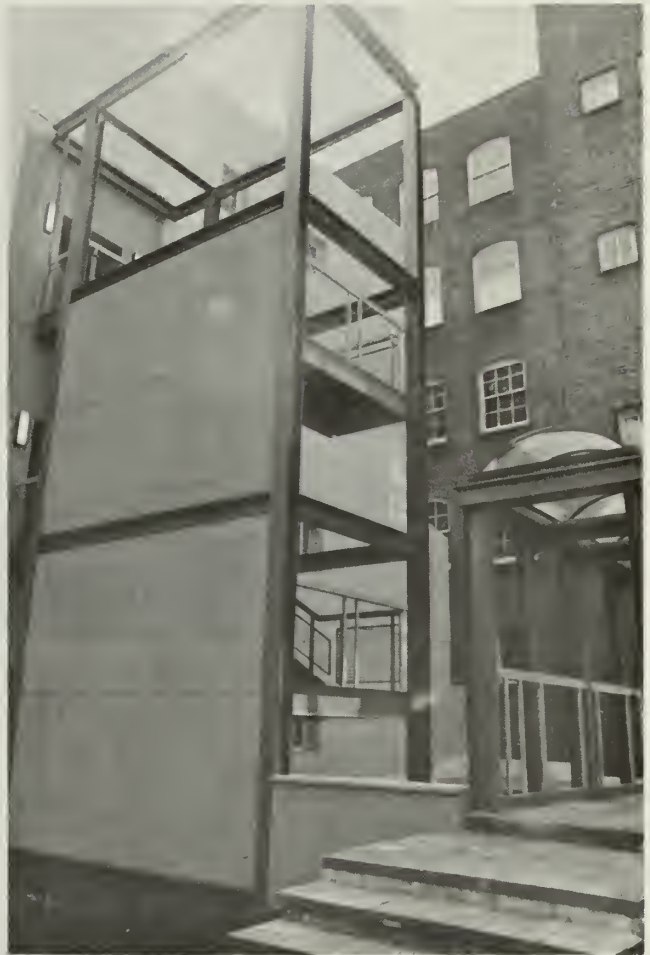
4. Stairtower provides fire exit from building at left.

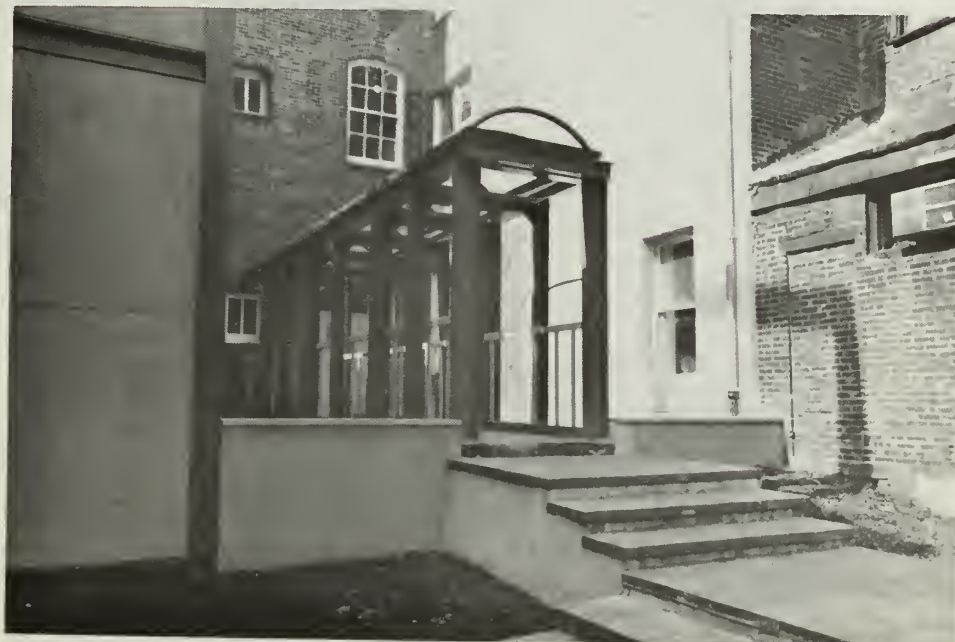
5. Covered walkway serves as the principal entrance to all four rehabilitated structures.

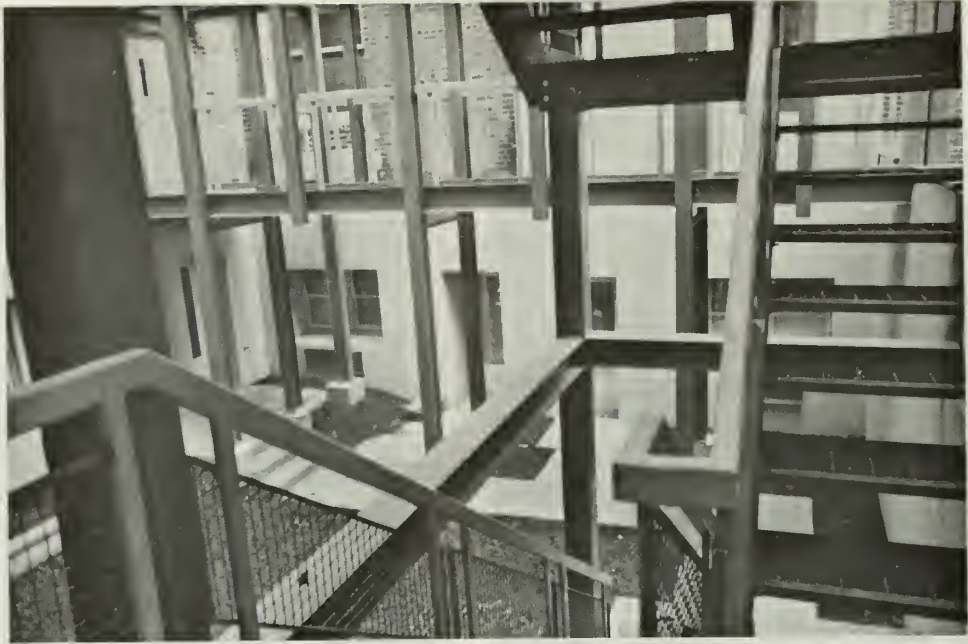
6. The covered walkway spans a courtyard excavated for new below-grade apartments.

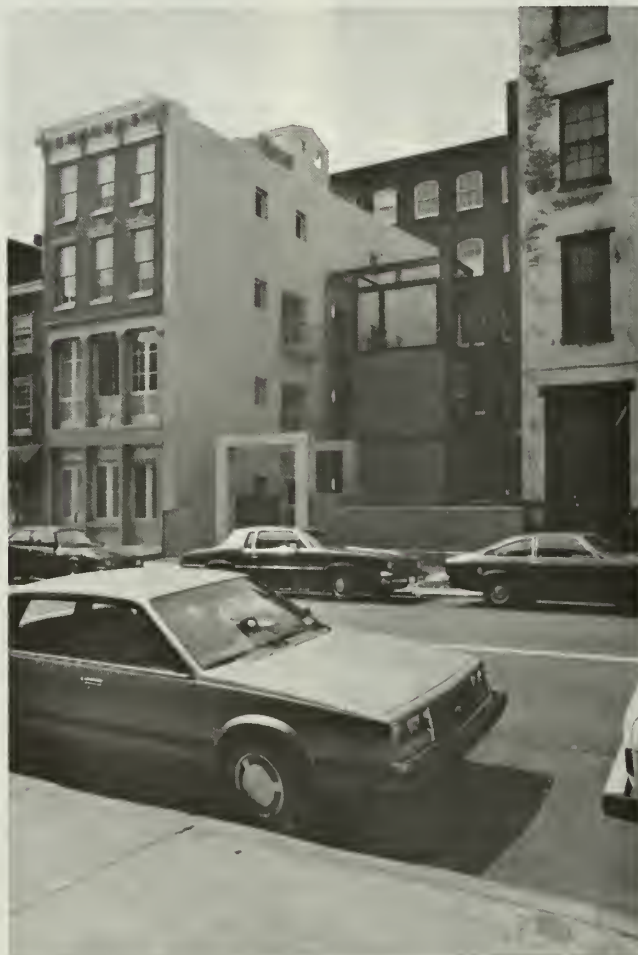
7. The new site work subordinates the independent historic building to a larger composition of radically new and incompatible elements.

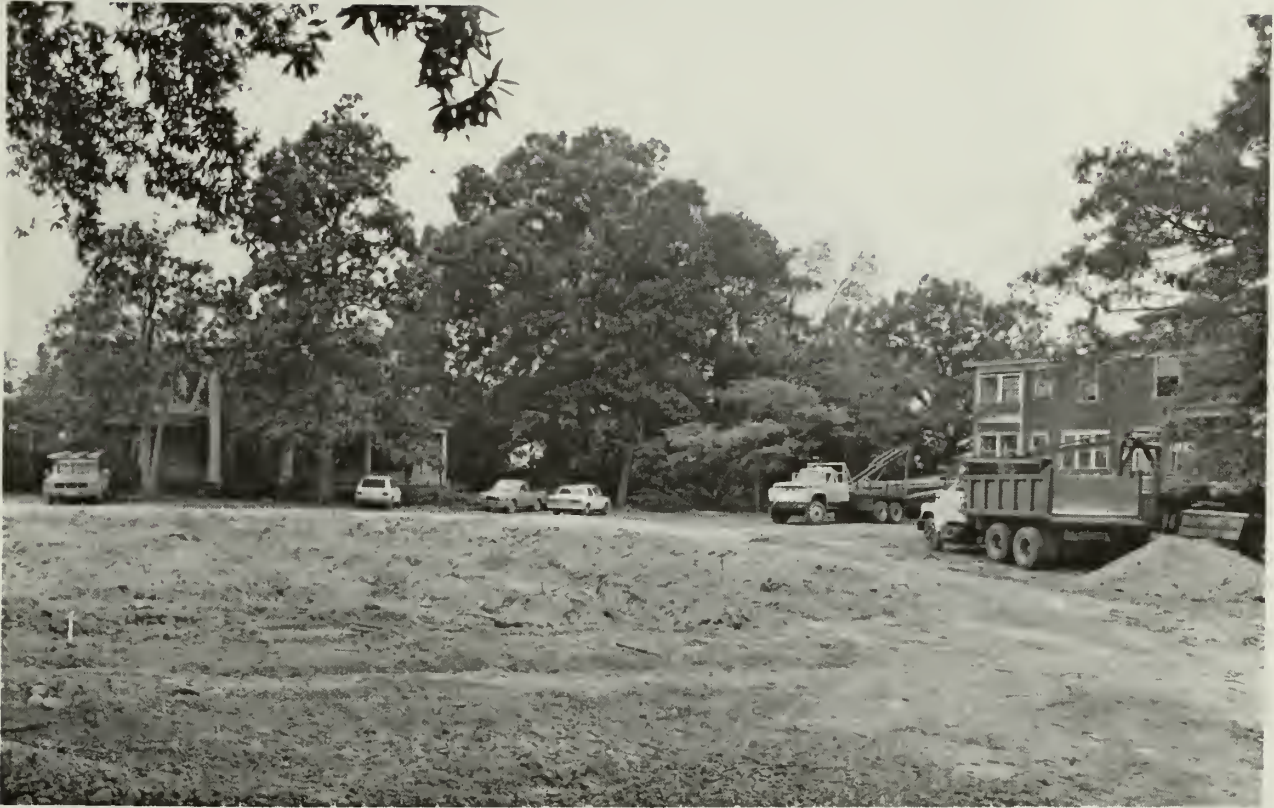
3. The front yard of the mansion has been prepared for the relocation of the neighboring house, seen at right.

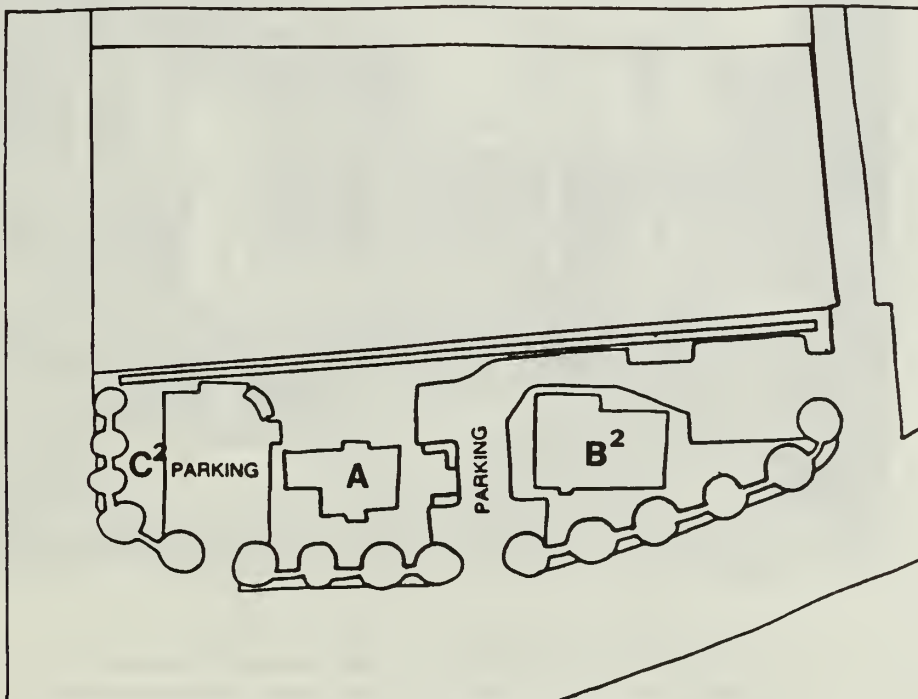
4. Site plan after relocation of buildings. The neighboring house was moved and turned around (B2) to face the 1900 building (A) across a paved parking lot. The cottage associated with the moved house was relocated (C2) behind the 1900 building.

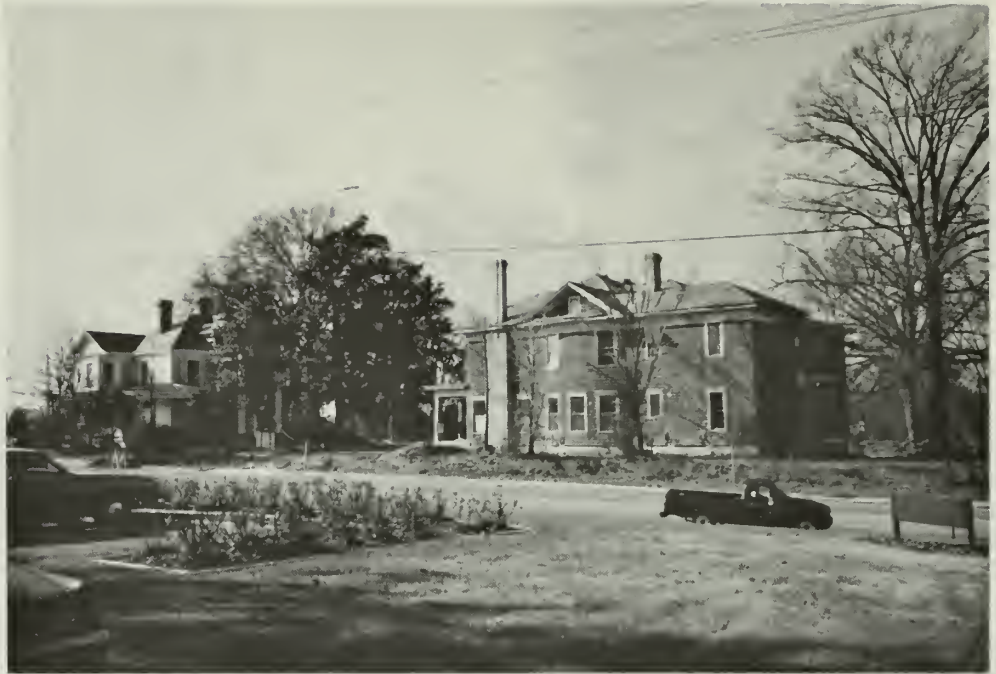
5. Turned 180 degrees, the moved building faces the historic one from a distance of 60 feet.

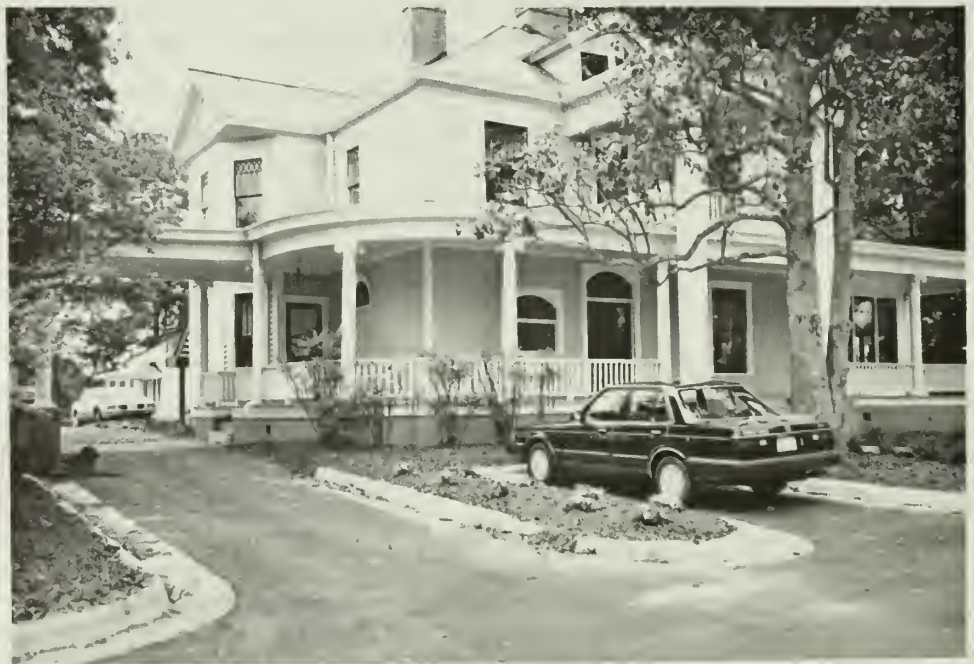
6. The parking lot completes the drastic alteration of the setting. The second relocated structure is seen through the porte-cochere at left

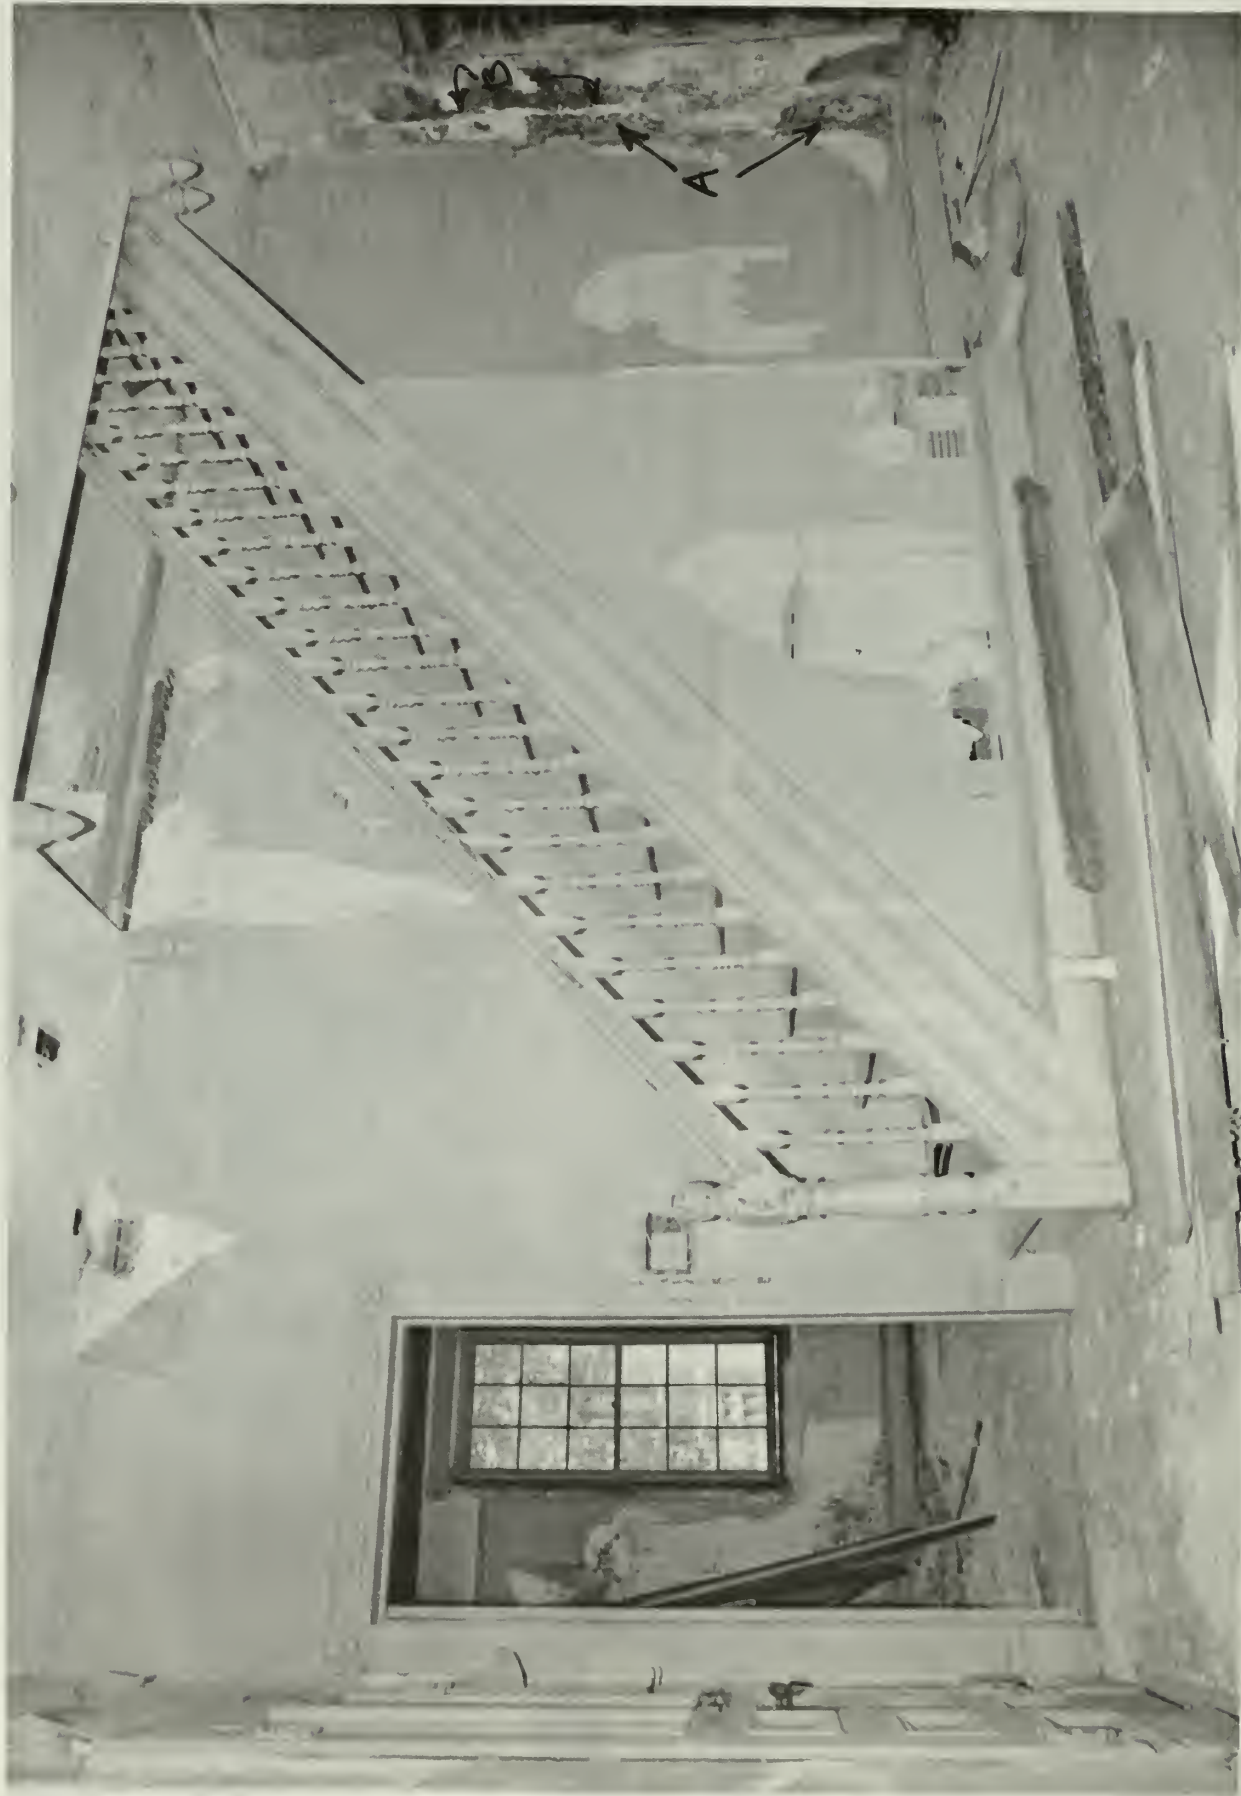
2. Circa 1912 stair prior to rehabilitation. Moldings, floor plan, and other detailing are all 20th century.
